Following the recent land survey undertaken for Erf 11275, we acknowledge the findings indicating:

- An encroachment of the building beyond the prescribed building lines.
- Roof apex heights exceeding the permitted 6.5m height restriction when measured from ground level.

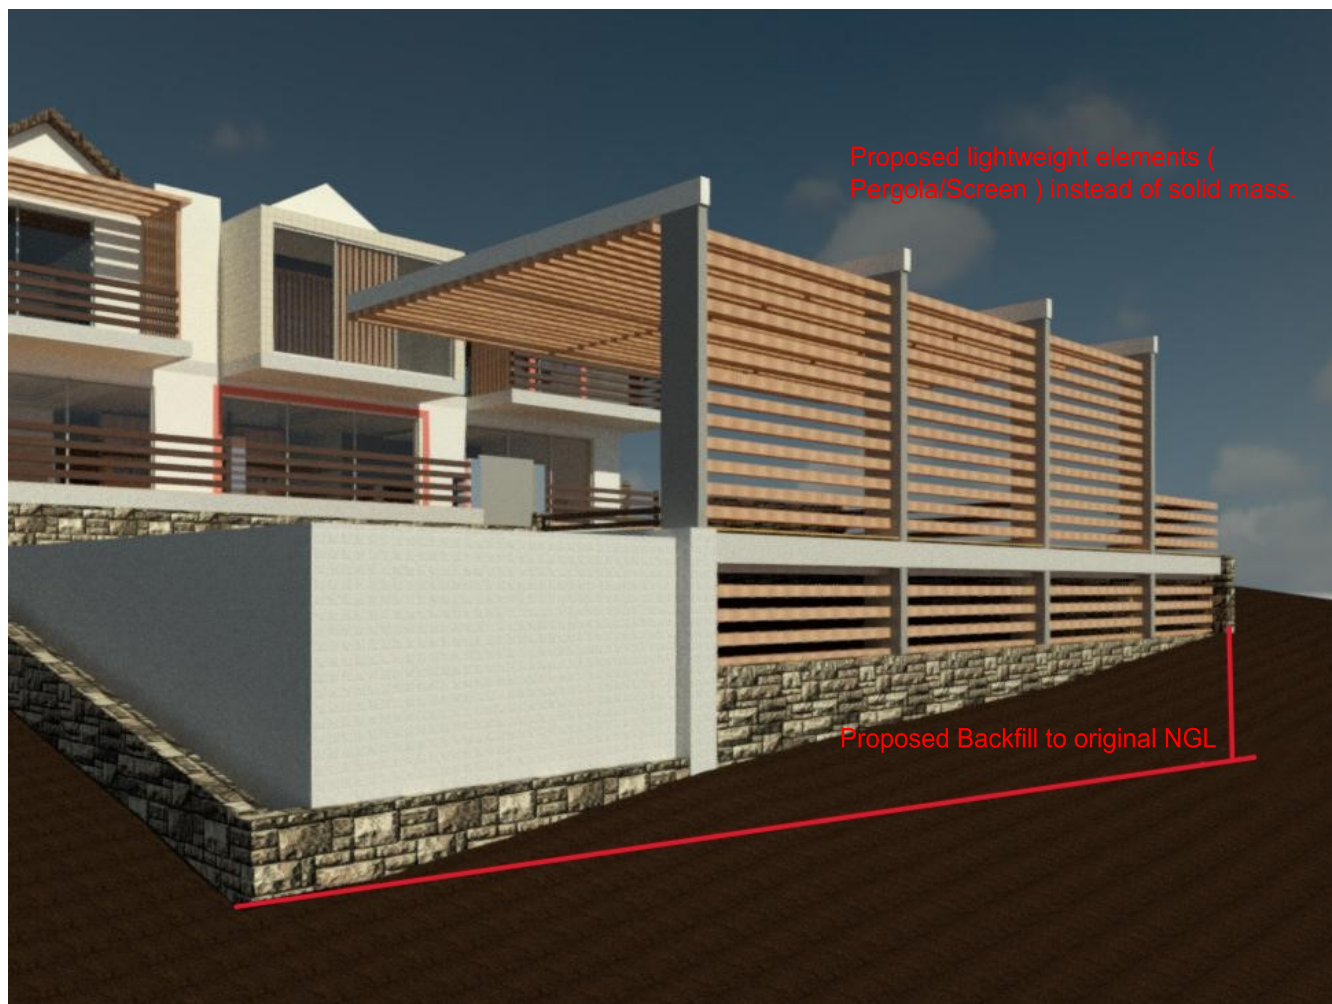
**Reduction of Built Form Dominance at Boundary**

We acknowledge that portions of the constructed building footprint extend beyond the approved building lines, as confirmed by the survey drawing .

This deviation arose due to a setting-out error during construction, where the building was incorrectly positioned on site. This was not intentional and was unfortunately not identified early enough during the construction process.

- Investigate the extent of encroachment and identify affected areas.
- Reduction of Built Form Dominance at Boundary - Treatment of encroaching portions to reduce visual and physical impact, such as:
  - Lower wall heights where feasible
  - Use of lightweight elements (e.g. pergolas, screens) instead of solid mass
  - Articulation of façades to break down scale
- Submit a formal relaxation application with full motivation, demonstrating minimal impact on adjacent properties , servitudes and services.
