**BAILEY & LE ROUX**  
PROFESSIONAL LAND SURVEYORS  
PROFESSIONELE LANDMETERS

**ERF 5395 KNYSNA : 'THE PROPERTY'**  
**REPORT : SURVEY OF THE HEIGHT OF THE BUILDING AND THE DETERMINATION**  
**OF NATURAL GROUND LEVEL**

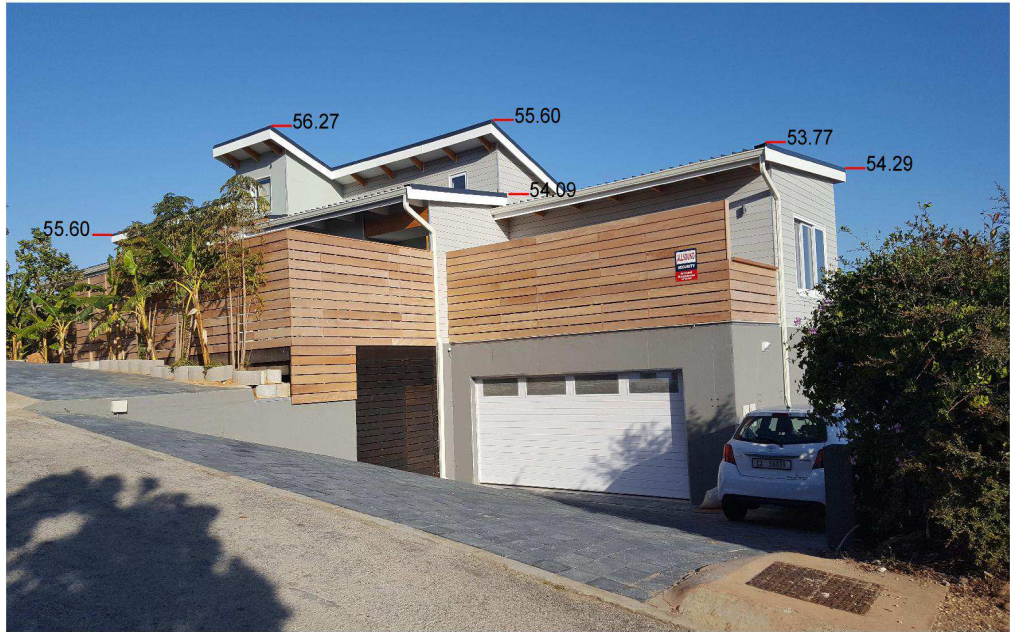
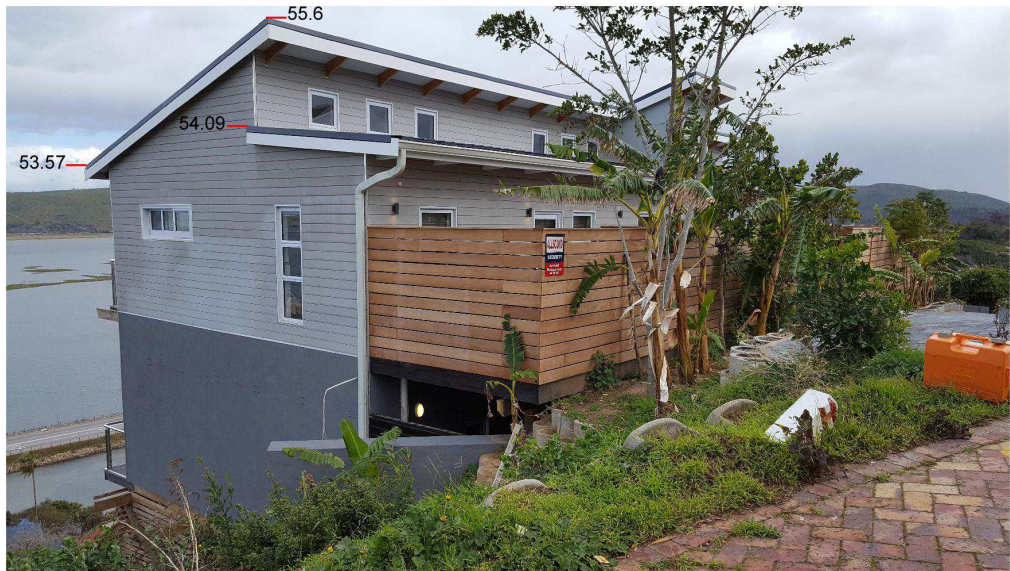
The roof of the building comprises 4 sections that have been investigated for compliance with the zoning scheme regulation.

- a) The western roof has on the northern side a height of 53,77 metres and on the southern side a height of 54,29.
- b) The eastern main roof of the building has a height of 53,57 metres on its southern side and on the northern side heights of 54,09, 55,60 and 56,27 metres.

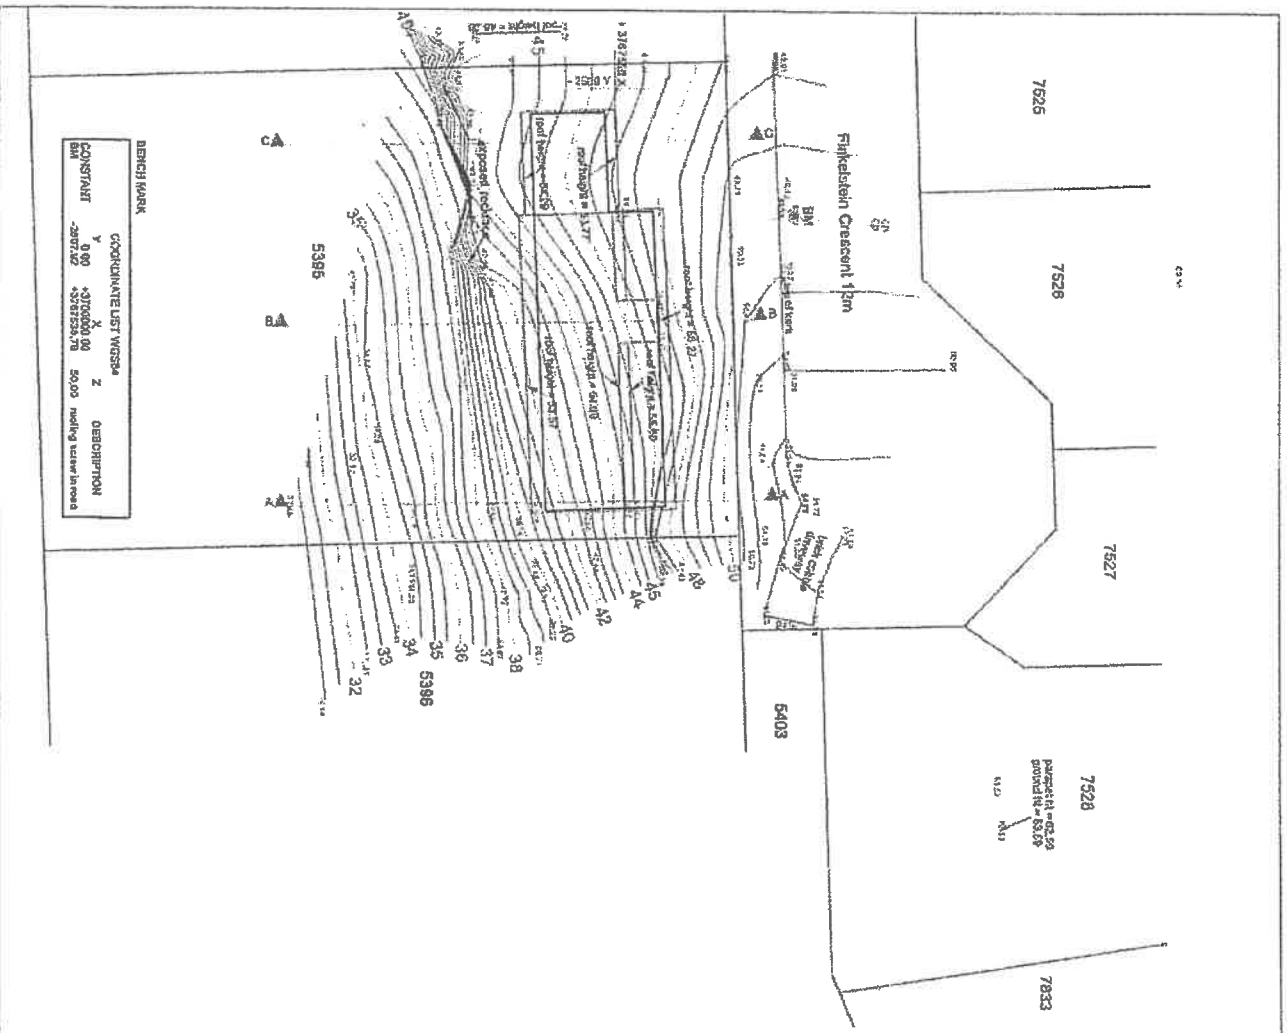
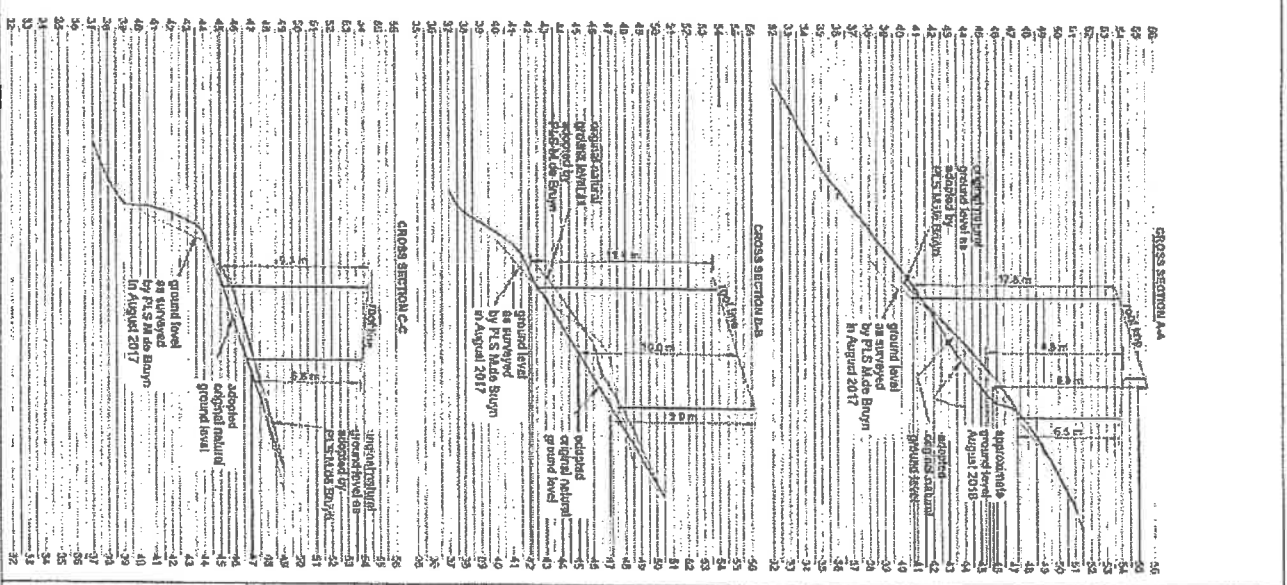
To determine the height of the building relative to the ground levels cross sections were prepared at A-A, B-B and C-C which show the roof heights in relation to the natural ground heights.(see plans 699KN1A.DRG and 699KN1B.DRG)

The cross sections A-A, B-B and C-C have incorporated the levels as surveyed by Mr de Bruyn and are represented by the green lines on each cross section.

That the building at cross section A-A complies at the roof height of 53,8 and 54,09 and not at heights 55,6 and 53,57 metres.

That the building at cross section B-B complies at the roof height of 56,27 and does not comply at the roof height of 53,57 and 55,2 metres.

That the building at cross section C-C complies at the roof height of 53,77 and does not comply at roof height of 54,29 metres.
