# PROPOSED KNYSNA LAKE CABINS DEVELOPMENT ON PORTION 192 OF FARM 216 UITZIGT, BRENTON ON LAKE, KNYSNA.

## Aquatic Specialist Assessment

**Author:** J.M. Dabrowski (PhD)  
Confluent Environmental Pty (Ltd)  
7 St. Johns Street,  
Dormehlsdrift,  
George, 6529

**Date:** 14 January 2026

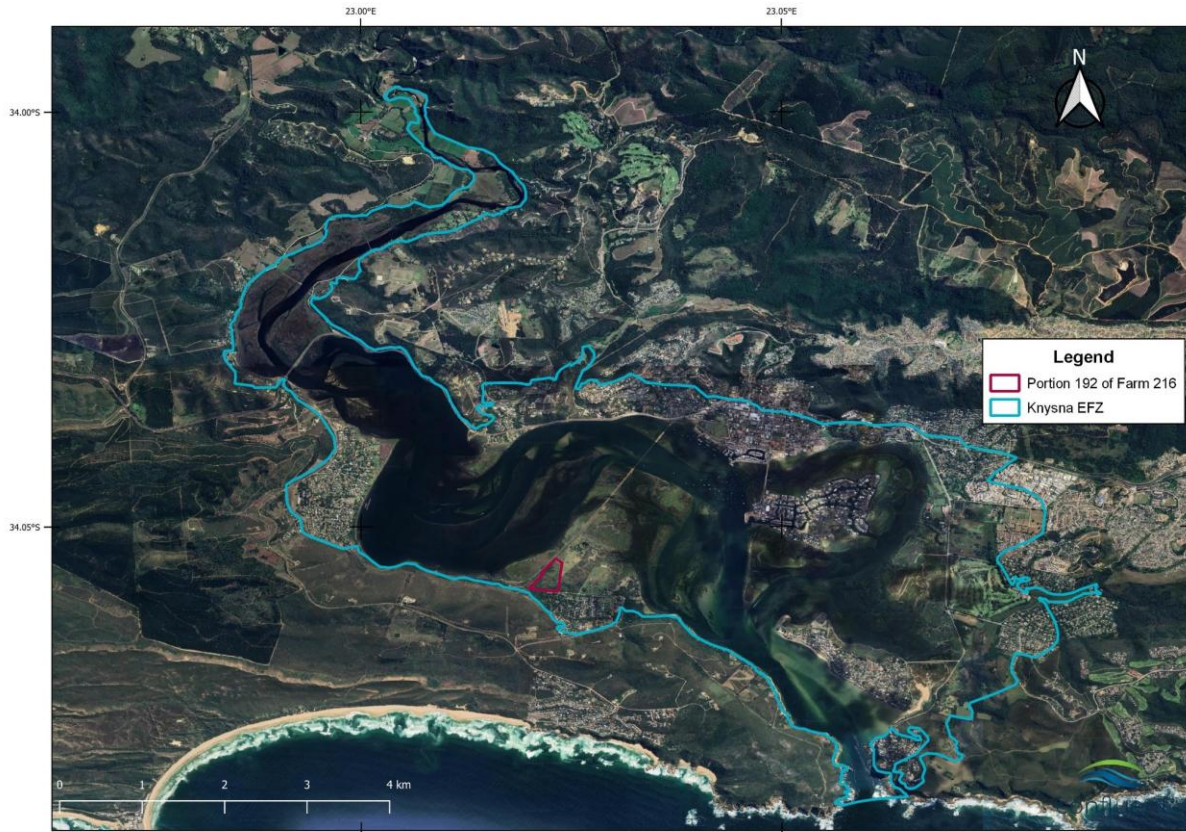
*Figure 2: Location of Portion 192 of Farm 216 relative to the Knysna EFZ.*

and therefore include large areas of land (much of which has been developed) that border the actual open estuarine water body. The EFZ is now commonly used to delineate the spatial extent of the entire estuary. Large sections of the Knysna EFZ have been historically developed into residential and agricultural properties (Figure 2). From Figure 3 it is evident that the entire settlement of Brenton-on-Lake is located within the EFZ.

biological processes and adjacent habitats necessary for estuarine function and health (Van Niekerk et al., 2019b). It includes all dynamic areas influenced by long-term estuarine sedimentary processes, multiple ecotones of floodplain and estuarine vegetation that contribute organic material and provide refuge from strong currents during high flow events. EFZs are currently delineated by the 5 m contour line and therefore include large areas of land (much of which has been developed) that border the actual water body. The EFZ is now commonly used to delineate the spatial extent of the entire estuary. In this respect large sections of the Knysna EFZ have been historically developed into residential and agricultural properties (Figure 2). T

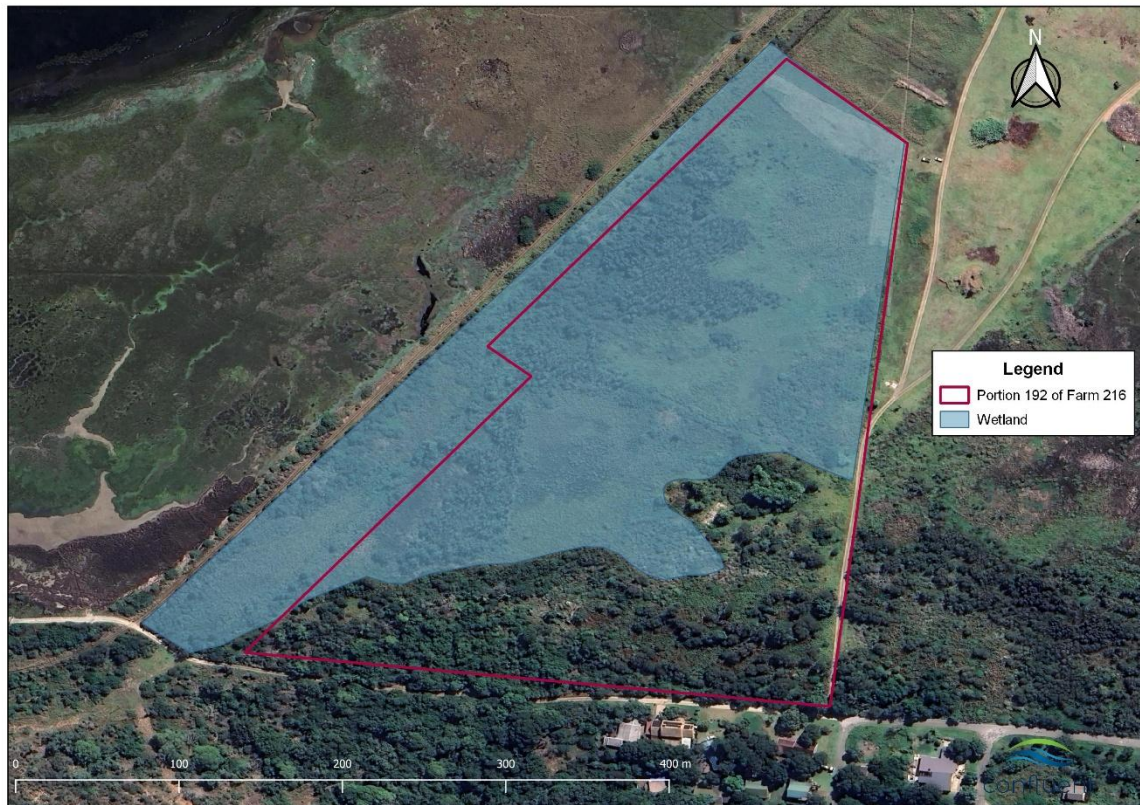
Figure 10: Map illustrating the delineated extent of estuarine wetland habitat in Portion 192 of Farm 216.

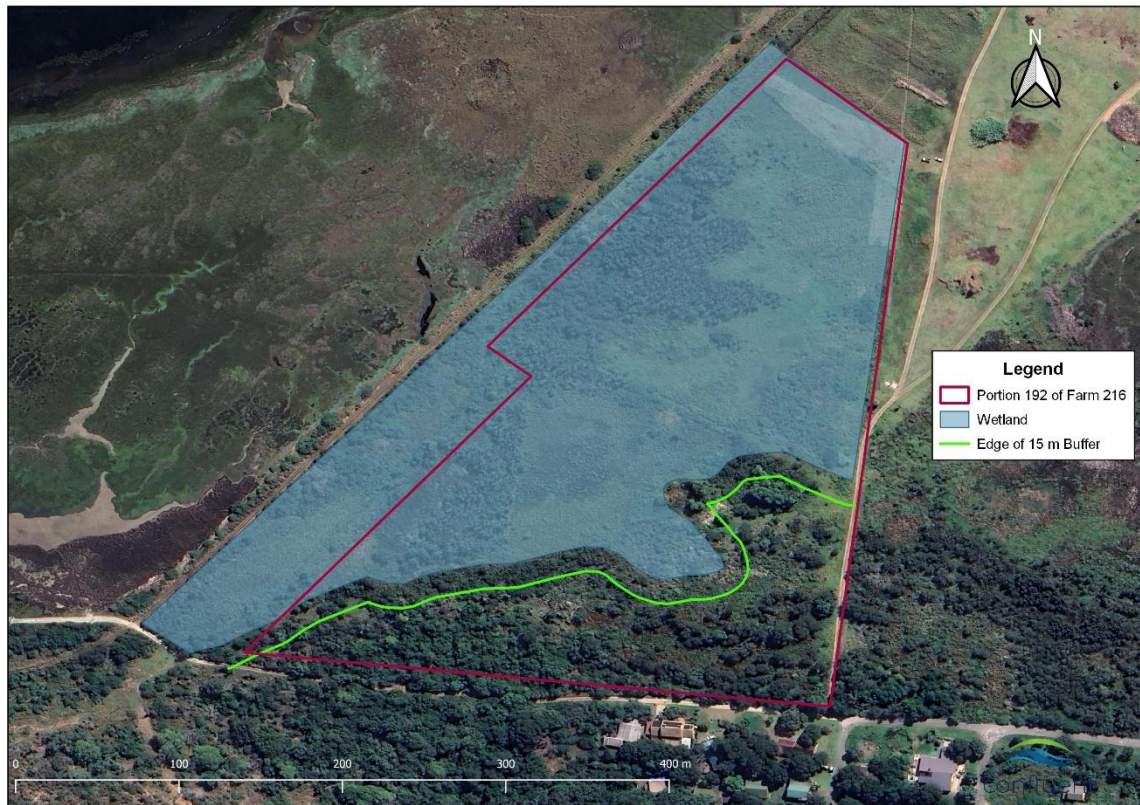
Figure 11: Map of the delineated estuarine wetland and the recommended 15 m buffer.

- Mean Annual Precipitation Class: 801 – 1000 mm.
- Rainfall Intensity: Zone 4.
- The inherent runoff potential of soil in the catchment area is Low (A/B soils).
- Average slope of the rivers catchment is < 0.2 %.
- The slope of the buffer area is very gentle (0 – 2 %).
- Interception characteristics of the vegetation is considered to be Good (moderately robust vegetation with good interception potential).

Based on these inputs the buffer for estuarine wetland area is set to 15 m (Figure 11).

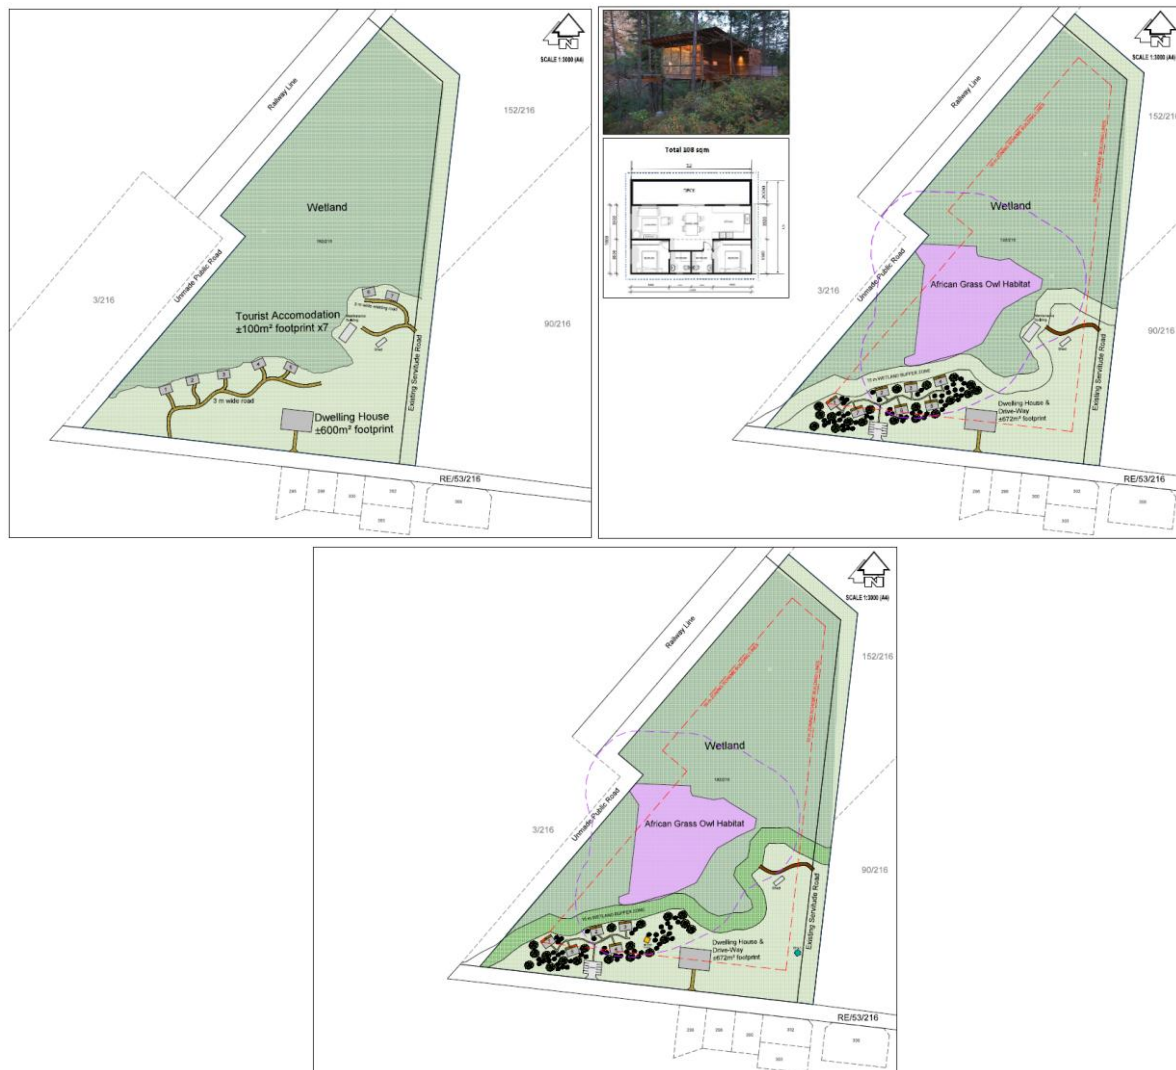
Figure 12: Alternative SDPs for Portion 192 of Farm 216 (Alternative 1 – left; Alternative 2 – right and Alternative 3 – bottom).

Site sensitivities provided by multiple specialists (including terrestrial, botanical, faunal and aquatic) were used to inform the site development plan (SDP). The SDP includes a proposal for tourist accommodation buildings, each covering ca 108 sqm. In addition to the tourist accommodation, a main dwelling house covering ca. 672 sqm is proposed, and one small shed and a maintenance building is also proposed (191 sqm in total). These structures are apart from the accommodation chalets as there are existing building ruins in the area where they are planned. The original SDP (Alternative 1) was primarily informed by the delineation of estuarine wetland habitat. Specialist reports were then used to inform the first revision of the SDP during September of 2025 which included the minimum requirement of a 15 m buffer around the edge of the delineated estuarine wetland habitat (Alternative 2). All tourist cabins and the residential dwelling have been moved outside of the 15 m buffer. The exception is the maintenance building which will be constructed on an existing building footprint located within the buffer. Alternative 2 represents a more clustered layout (i.e., all the buildings are clustered together to avoid a spread-out footprint) and includes a parking lot covering ca. 265 sqm, as well as a boardwalk between dwellings of ca. 174 sqm. Alternative 3 reduces the number of cabins from six to five and removes the maintenance shed from within the 15 m wetland buffer.

In terms of the mitigation hierarchy, Alternative 2 and 3, which both include the implementation of a 15 m buffer avoids any direct impacts or disturbance to estuarine wetland habitat and is considered the preferred option. Due to the flat topography of the site and the low density of the development, stormwater discharge into estuarine wetland habitat is unlikely to pose any impact towards estuarine wetland habitat. Assuming that recommended mitigation measures are implemented, the ecological condition of the broader Knysna Estuary and the estuarine habitat located on the property is unlikely to be negatively impacted by Alternative 2 and 3. In terms of avoiding and minimising impacts to aquatic biodiversity, Alternative 2 and 3 are supported for further environmental authorisation – with Alternative 3 being the preferred option as all infrastructure will remain outside of the buffer. Alternative 1 is not recommended.
